INTRUDERS FROM THE SEA

USN/USMC A-6A, A-6B, & KA-6D Intruders in the Vietnam War

For Hobby Boss 1/48 A-6A Intruder

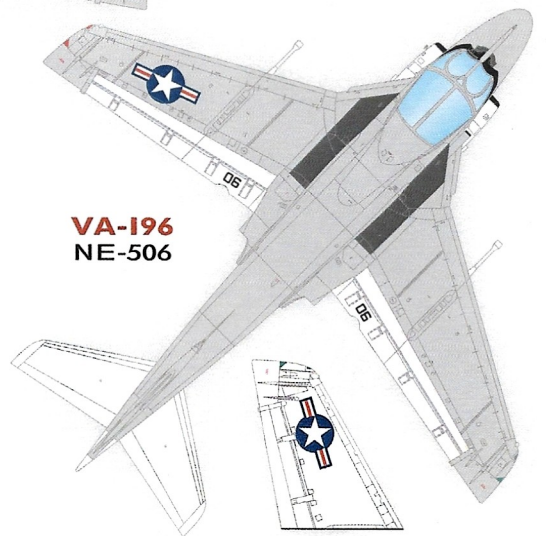
VA-196
NE-506

Fuselage markings are not shown in overhead views.
Note the standard position of the lower wing's national insignia was originally located further outboard.

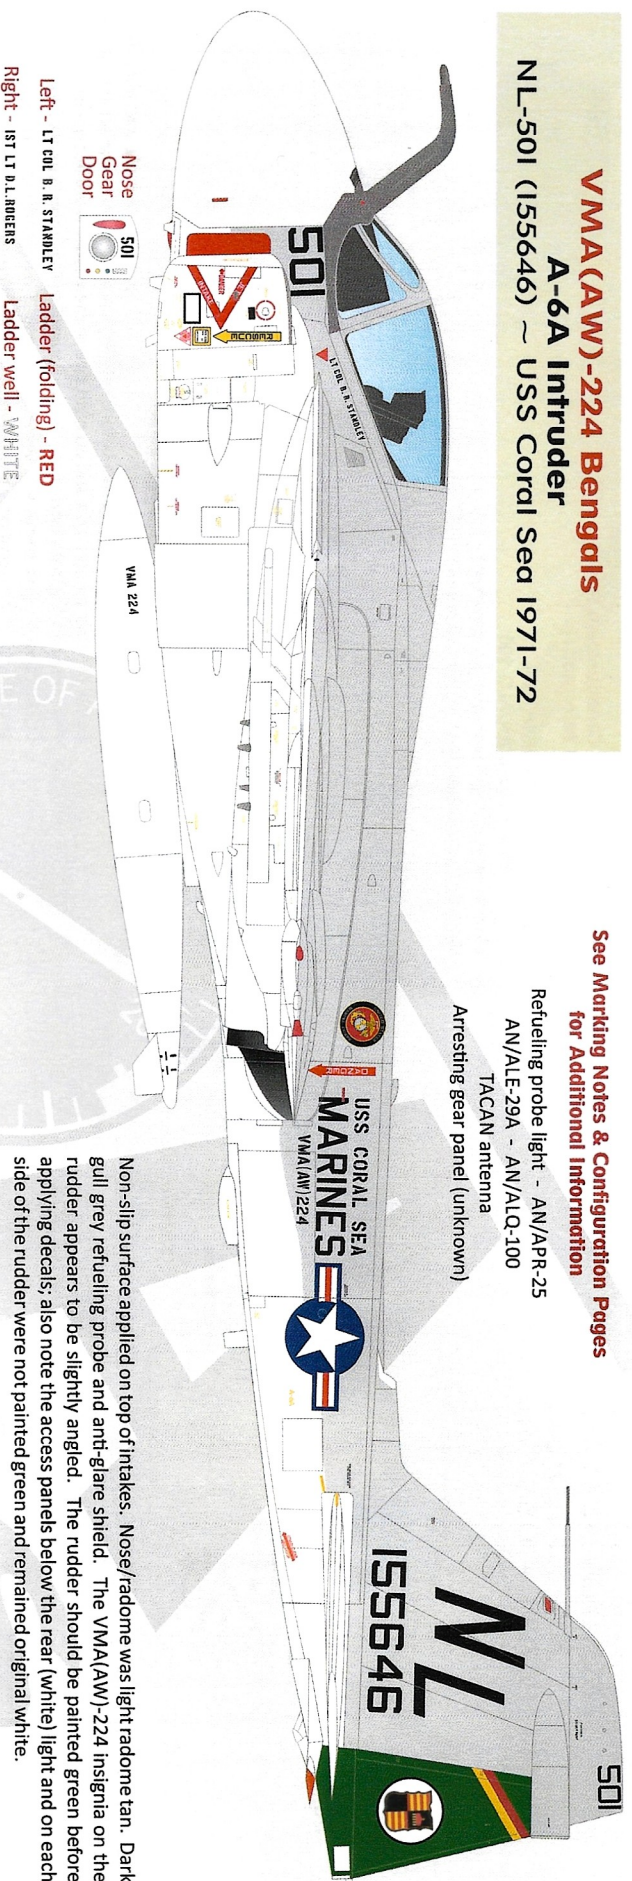
VMA(AW)-224 Bengals
A-6A Intruder
 NL-501 (155646) ~ USS Coral Sea 1971-72

Refueling probe light - AN/APR-25
 AN/ALE-29A - AN/ALQ-100

TACAN antenna

Arresting gear panel (unknown)

Non-slip surface applied on top of intakes. Nose/radome was light radome tan. Dark gull grey refueling probe and anti-glare shield. The VMA(AW)-224 insignia on the rudder appears to be slightly angled. The rudder should be painted green before applying decals; also note the access panels below the rear (white) light and on each side of the rudder were not painted green and remained original white.
