AeroMaster™

Too Little, Too Late

Part II Fw 190D-9's

Suggested Kit: Tamiya 1/48 Fw 190D-9

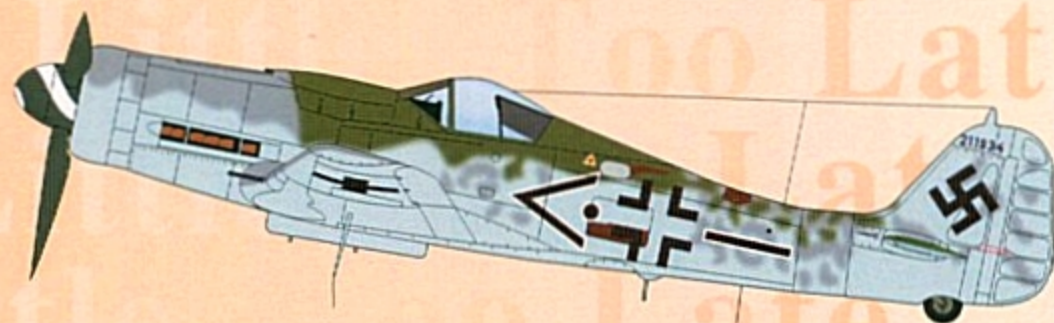
This conventionally painted "Dora" of I/JG301 in the Spring 1945, features the more common "banded" pattern of RLM75 and RLM83 Dunkelgrün over RLM76. Note the empennage mottling and personal marking, alternate starboard variations of which we have supplied, if in fact it was ever carried! Black spinner and RLM70 wooden propeller. A/C flown by Feldwebel Hagen Förster. W.Nr. for this A/C is fictitious, use only if so desire.

Very Dirty appearance on these A/C specially around the exhaust/ fuselage area.

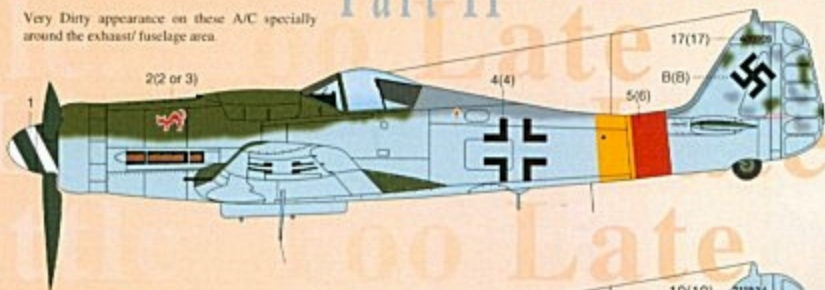
This "Dora" of I/JG6 in March 1945, also features the common "banded" pattern of RLM75 and RLM83 Dunkelgrün over RLM76. Note the additional mottling of RLM83 and RLM75, as well as the primer areas and metal fuel access door. Upper wing surfaces may have sections of RLM82/83/75. Photo on page 71 (Ref. 1) shows a very washed out (almost gray) fuselage cross and possibly swastika. Also, another photo is available on reference 4, page 20.

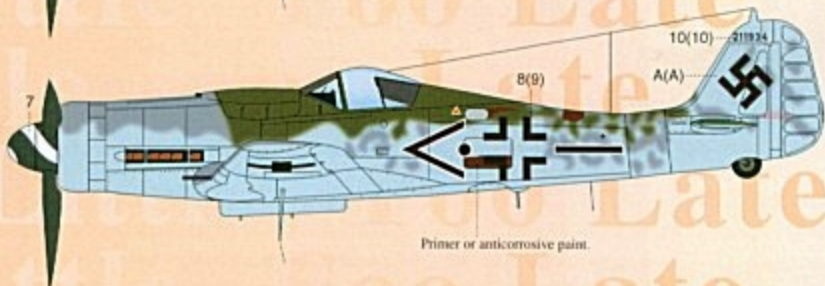
Primer or anticorrosive paint.

Despite being well photographed, controversy surrounds this extremely interesting Fw190D-9 of I/JG6. Surrendered to the Allies at Fürth in May 1945, this machine is routinely called "Black 12." Look at picture on page 70 of S.S. Walkaround! The patchwork scheme consists of a fuselage pattern of RLM83 Braunviolett and RLM82 Lichtgrün over RLM84 Graublau with a tarnished metal ventral fuselage. Upper wings were RLM 75 Grauviolett over either RLM76 Lichtblau or RLM77 Lichtgrün in slightly modified standard pattern. Note the RLM70 prop & spinner, spinner may have been Black! RLM76 rudder with RLM75 mottling, and hand-painted RLM 70 & red primer patches near the stabilizer roots and left fuselage panel. Note, too, hand-applied primer strips along ventral wing joints and on the Dk Green main gear doors. Tail and wing undersurface are believed to be RLM 84 with some areas in 76.

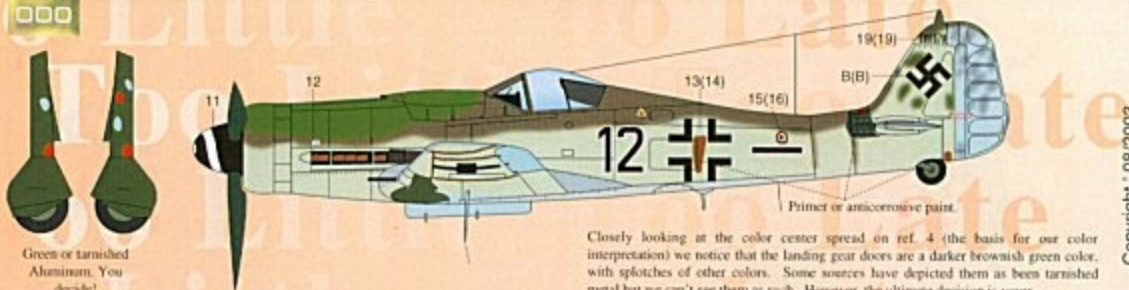
Primer or anticorrosive paint.

Closely looking at the color center spread on ref. 4 (the basis for our color interpretation) we notice that the landing gear doors are a darker brownish green color, with splashes of other colors. Some sources have depicted them as being tarnished metal but we can't see them as such. However, the ultimate decision is yours.

Green or tarnished Aluminum. You decide!
