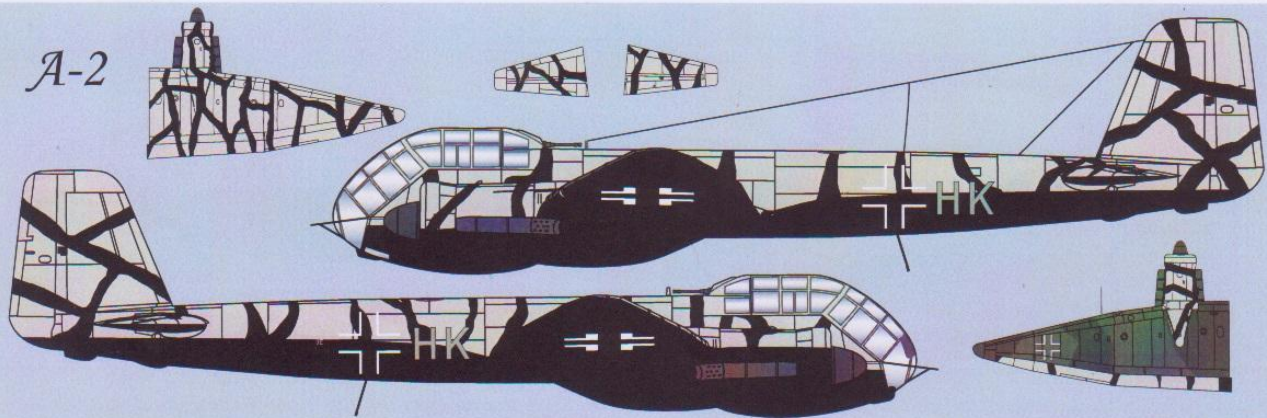
'3E+HK' is a A-2 of II/KG 6 found abandoned at Melsbroek in Belgium. The deletion of upper and forward cannon may indicate that this machine operated as a fast pathfinder/target illuminator aircraft. The camouflage pattern and replacement left main wing make an interesting project. Note that the grey code letters 'HK' have thin black outlines. Also be aware that the black splinter on the extreme tip of the left face of the vertical stabiliser, as well as that on the upper wing nacelles is conjecture. Machine has no tail wheel mud guard. John Adams collection. Luftwaffe Colours, Hikoki, p.111. AJ.Press Monograph Ju 188, Ju 388 vol. 2, p.5, 62
