# M54A2 5-TON 6X6 CARGO GUN TRUCK

# M54 5t Cargo Truck series

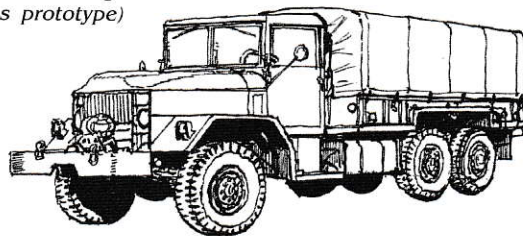
## M41 6x6 Cargo Truck

(M54's prototype)

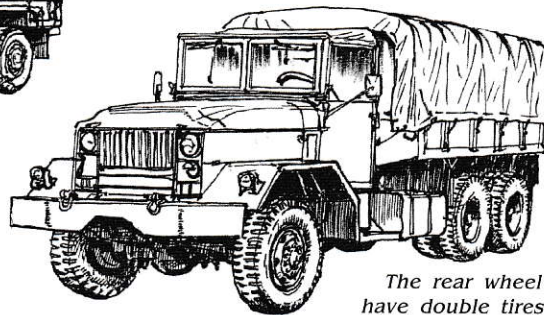
## M54 6x8 Cargo Truck

The rear wheel part have double tires and increase the carry load.

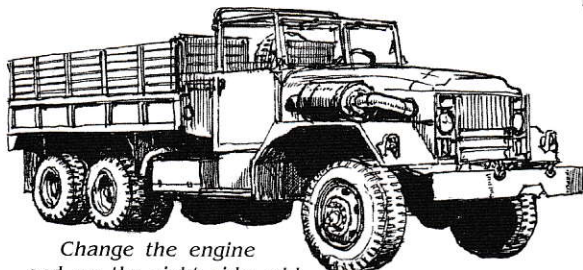
## M54A1 Cargo Truck

Change the engine and on the right side add a huge oil bus type air cleaner.

After the A1 type, having a chimney style exhaust pipe.

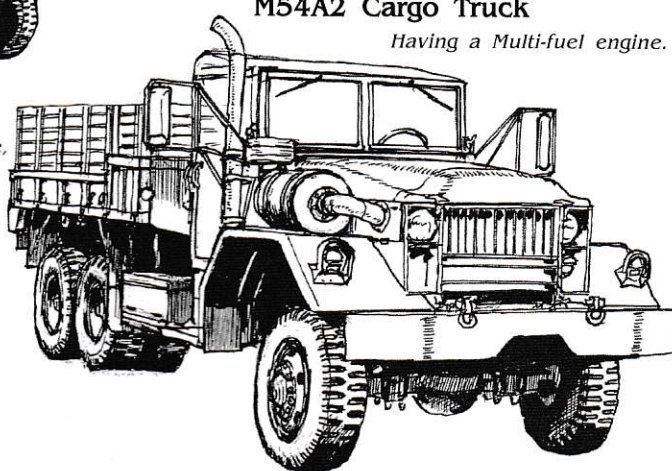
## M54A2 Cargo Truck

Having a Multi-fuel engine.

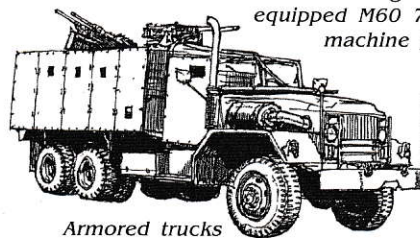
## M54A2 Gun Truck

Centered on M2 .50cal machine gun and equipped M60 7.62mm machine gun, ect.

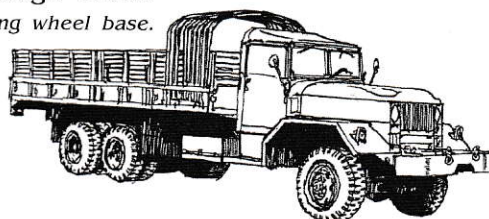
## M55 Cargo Truck

Long wheel base.

Armored trucks made to protect conroy during the Vietnam War.

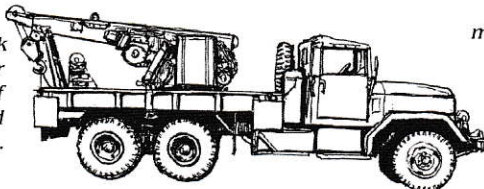
## M543 Wrecker

It is a flexible and practical truck used to repair various types of vehicles and construction.

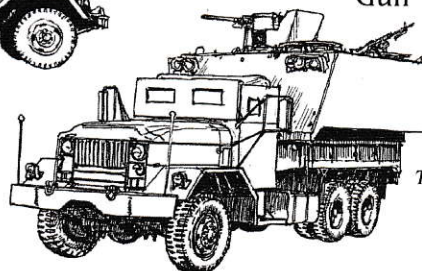
## Gun Truck with M113

The bucket load a M113 APC body's Gun Truck.

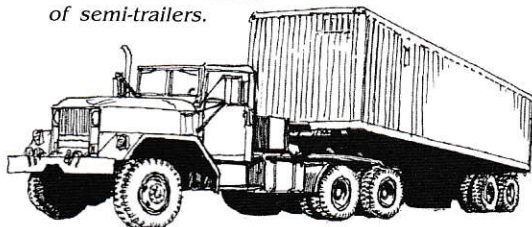
## M52 Tractor Truck

Used to tow all kinds of semi-trailers.
